Department of Planning, Housing, & Community Development

Subject: 21 Chenango Street - Signage Review

Tax ID: 160.41-1-13.1 CAUD 2015-52 Case:

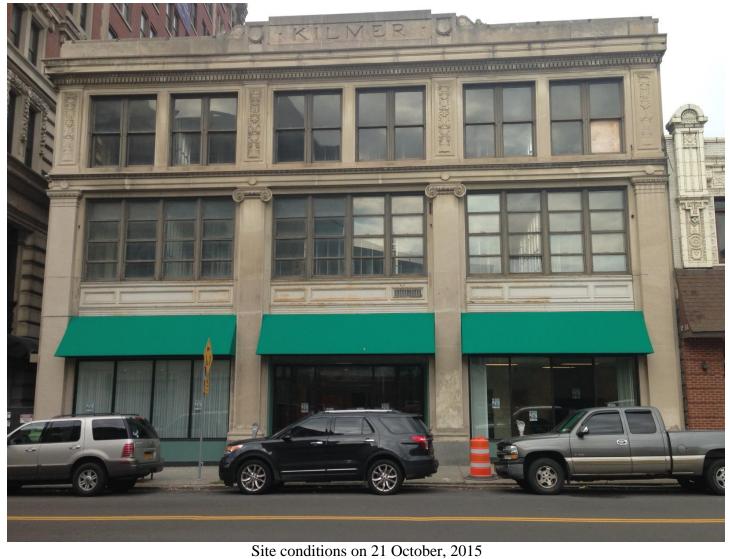
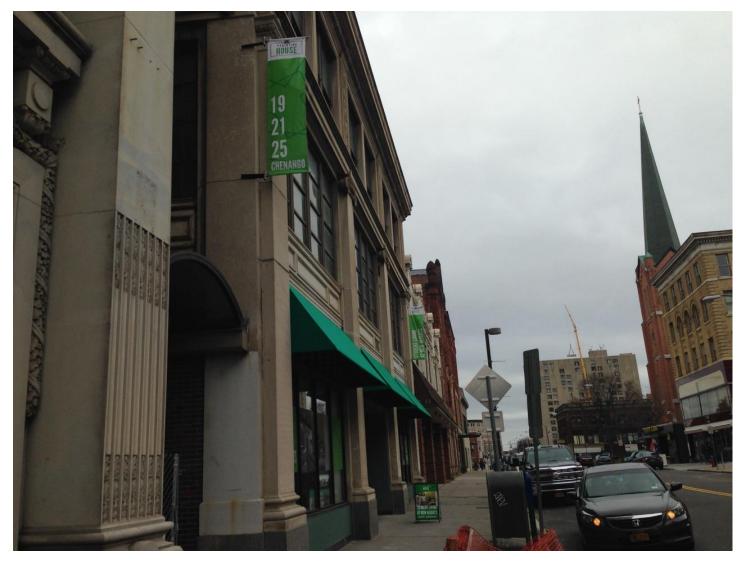
Current Conditions: notice the non-compliant projecting banner signage, not consistent with the Applicants previous proposal and the CAUD Approval decision. (November 18, 2015)

Additionally, the Applicant did not install the banner signage as proposed in the 27 October, 2015 CAUD meeting, making it out of compliance with zoning code, and in violation to the decision made at CAUD's October meeting. One (1) projecting banner sign is allowed per façade. The Applicant has placed two (2) projecting banner signs on the east, Chenango Street façade. The proposal showed that one of the projecting banner sign would be placed over press ally on the south façade.

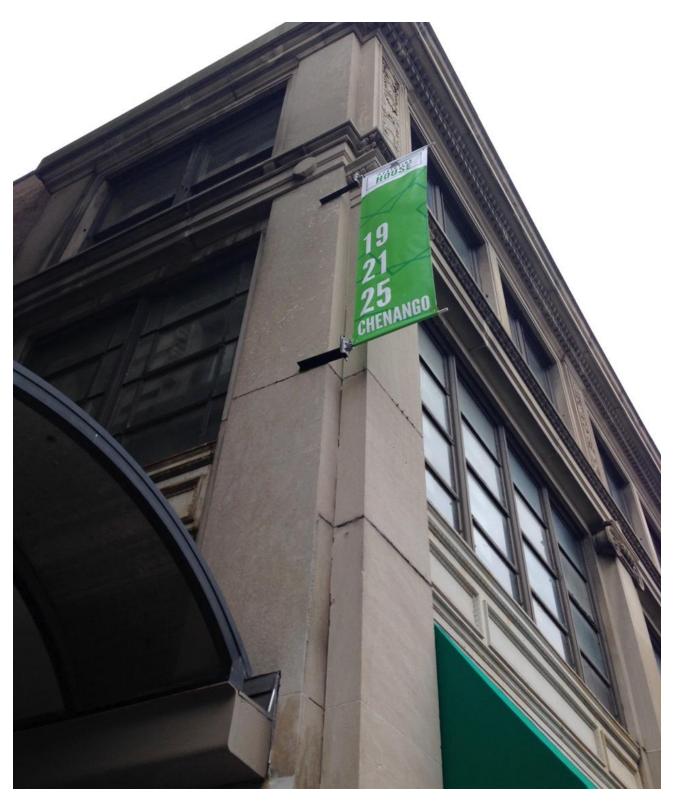
Photo detailing banner signage drilled directly into the façade in violation with the conditional approval of October 27^{th} (November 18, 2015)

As an update to the project implementation, the Commission should note that condition one (1), listed in section "B" above was violated with the installation of an approved projecting banner sign attached to the east facing façade. The banner was drilled directly into the stone façade of the building rather than mounted from the mortar joints as specified by the conditional approval.

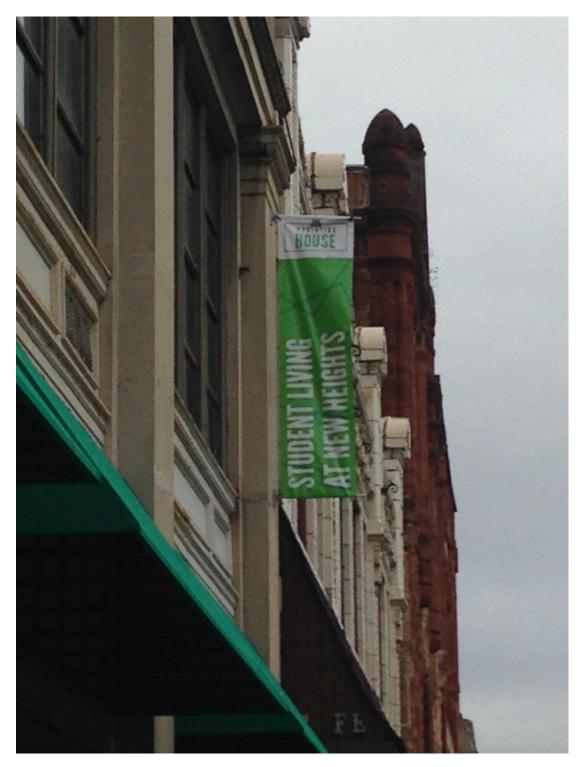
Another detailing of conditional approval violation – drilled into the stone facing of the building rather than mortar joints as specified in the decision. (November 18, 2015)
